# Burn-Through Fire Testing of Hardwire Panels Conducted November 2007 at UAB

To: Skip Ebaugh, Hardwire LLC

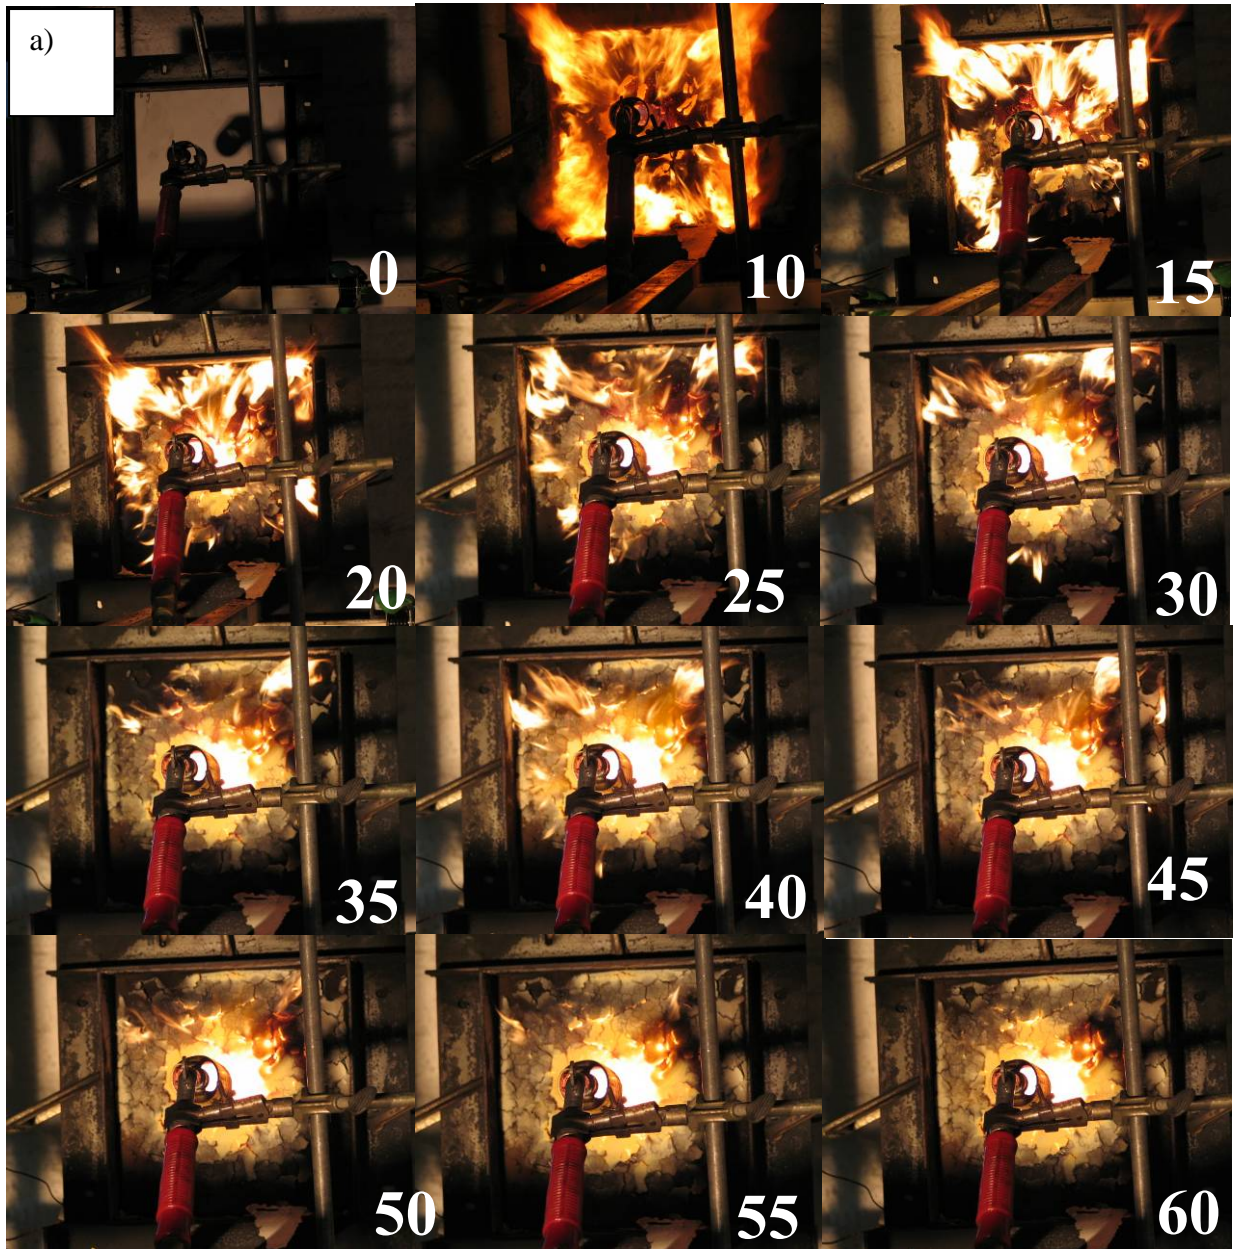
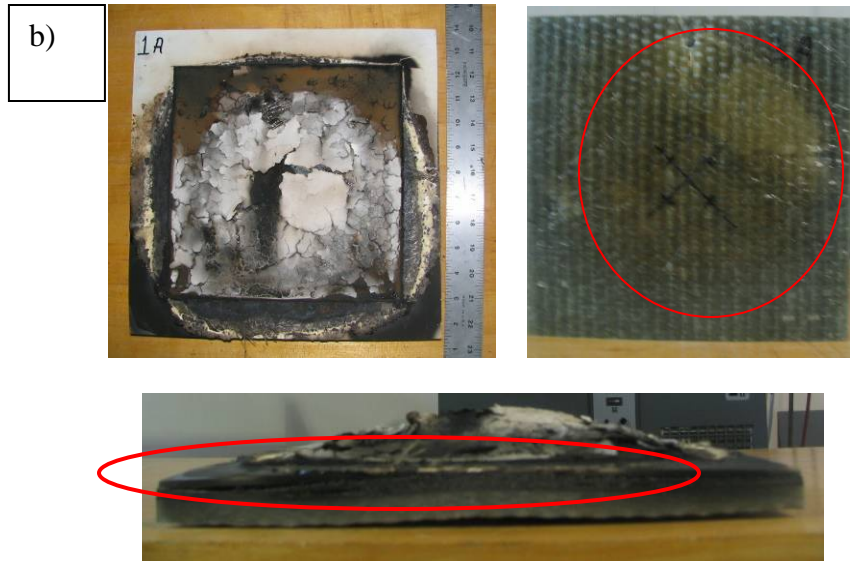
On completion of 60 minutes of burn-through testing, the temperature on the back face of the panel was found to be at  $218 \pm 2^\circ \text{C}$ . The temperature progression with time measured from the thermocouples attached to the back face of the panel is shown in Figure 4. The backside of the panel showed signs of visible damage, including some discoloration and delamination. The aluminum witness plate located 100mm from the back face registered temperature of  $43.1^\circ \text{C}$ . There was a mass loss percentage of 17.55 % on completion of the burn through test.

Fig. 3. a) Panel 1A Burn-Through progression (5 min intervals). b) Panel 1A, after burn through test. Back face and fire exposed side with delamination and damage

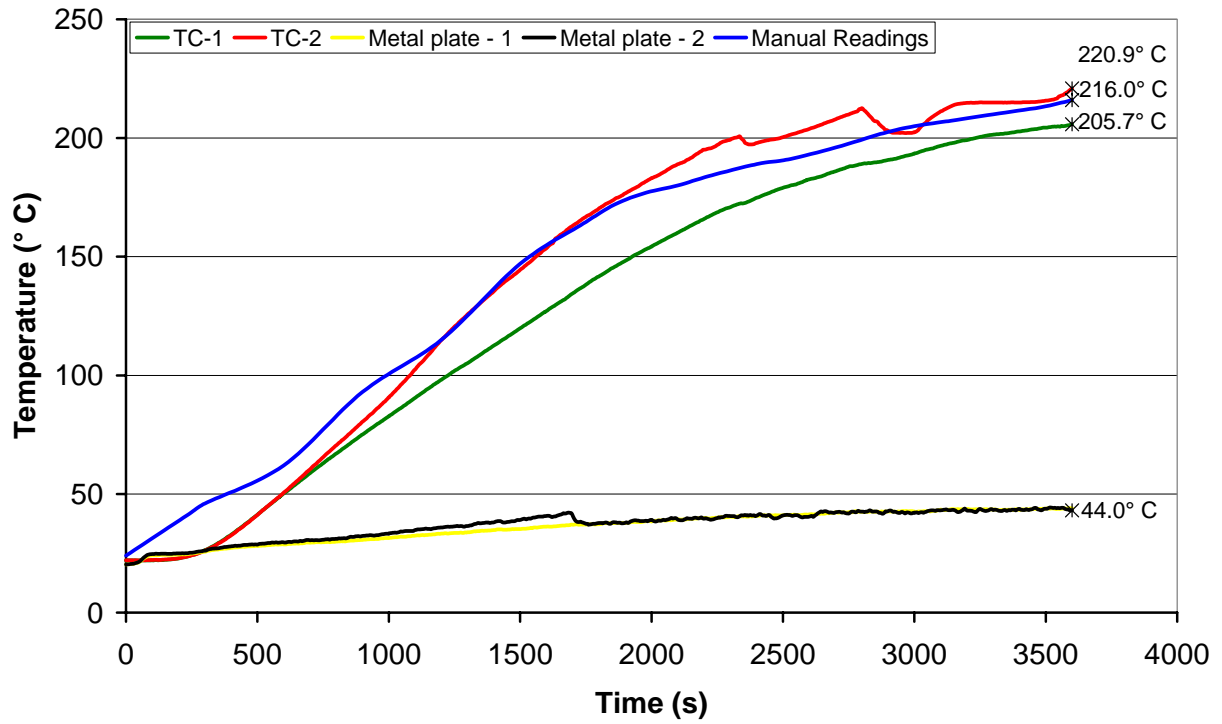
Figure 4. Temperature versus time for the burn-through test of Panel 1-A

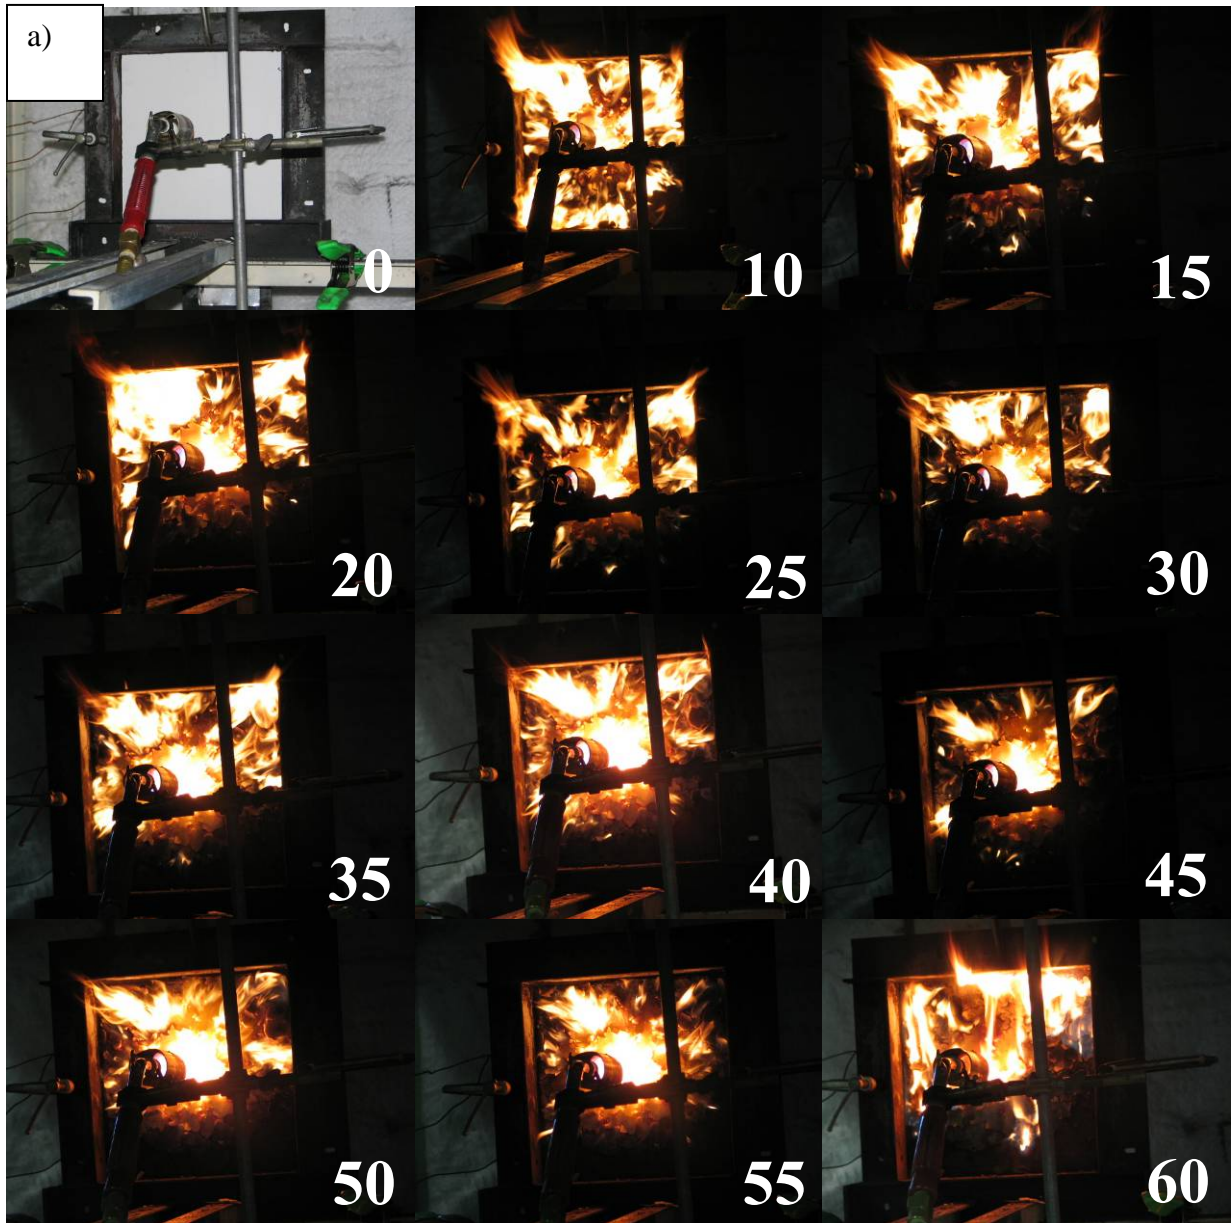
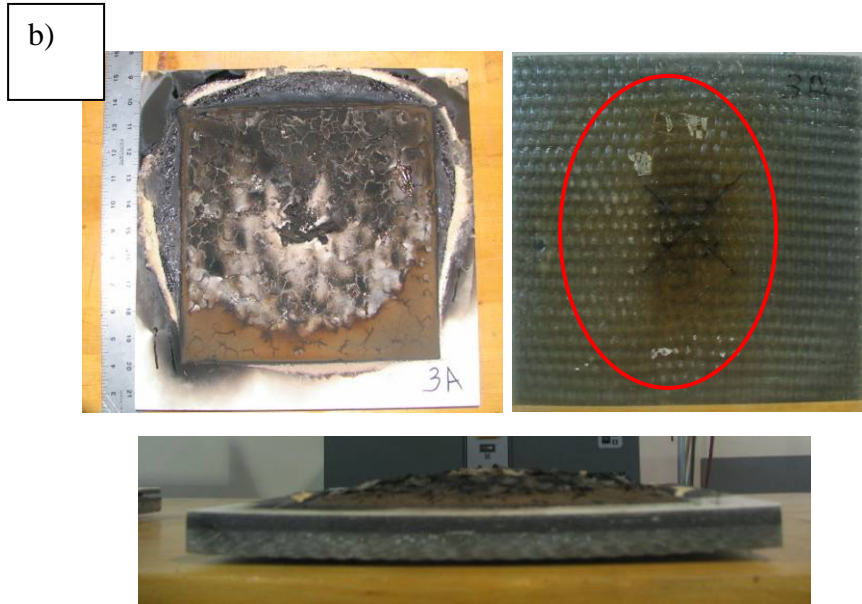
On completion of 60 minutes of burn-through testing, the temperature on the back face of the panel was found to be at  $220 \pm 2^\circ \text{C}$ . The temperature progression with time measured from the thermocouples attached to the back face of the panel is shown in Figure 7. The aluminum witness plate located 101.6mm from the back face registered temperature of  $46.5^\circ \text{C}$ . The plate experienced localized blistering in the fire side as the fire developed. **The backside of the plate showed no signs of damage, except for discoloration. In contrast Panel Type 1 had exhibited delamination for similar conditions.** There was a mass loss percentage of 17.63% on completion of the test.

Figure 6. a) Panel 3-A burn through progression (5 minute interval). b) Panel 3-A back face and fire side after burn through testing

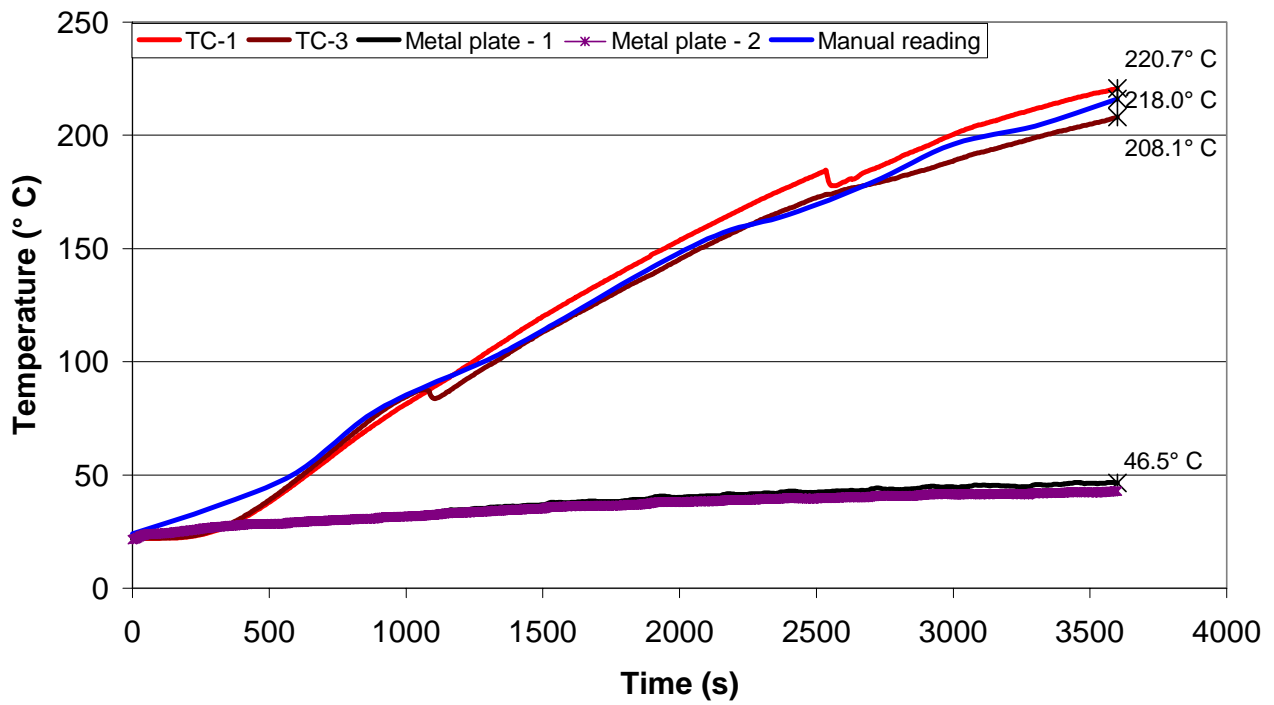
Figure 7. Temperature versus time for the burn-through testing of Panel 3-A.

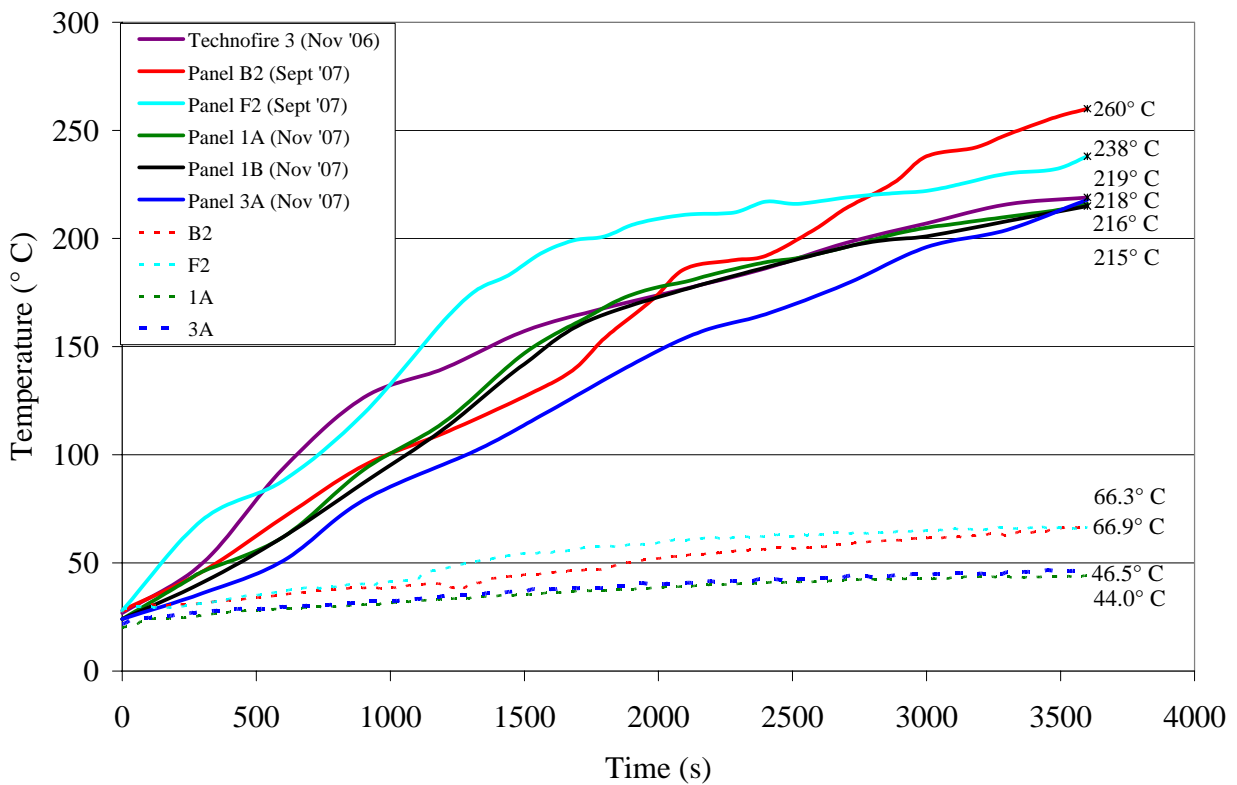
**Comparison of back face temperature progression versus time during a burn-through testing, for ALL the hardwire panels tested betn. November 2006 through November 2007.**

- The panels have a performance rating in the following order, based on their peak back-face temperature during burn-through testing for all panels tested Nov 06 to Nov 07 period.

$$\mathbf{B2 < F2 < Technofire\ 3 < 3A \leq 1A \approx 1B}$$
