The AEWC Center

Research
Report
Number
AEWC 05 – xx

Hardwire Reinforced Glulam Tests

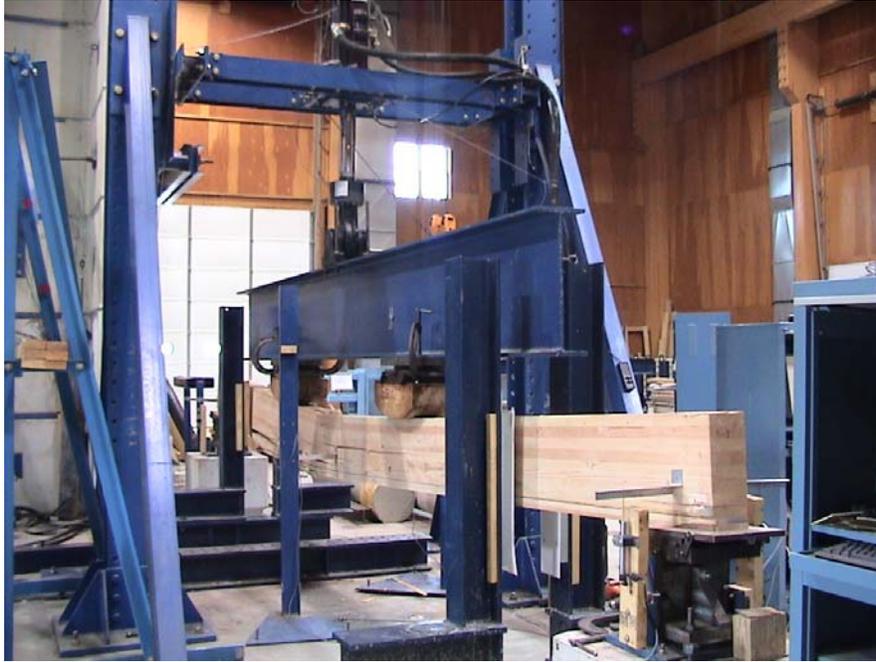
Figure 2: ASTM D 198 Four-Point Bending Test Set up

Following ASTM D198, a four-point flexure test was set up under a 55-kip Instron Hydraulic Actuator, as shown in Figure 2.

A span of 21-ft was used, with a load span of 7-ft. Load data were collected from the Instron computer tower, and deflections at mid-span and at the supports were measured using Linear Variable Displacement Transducers (LVDTs).

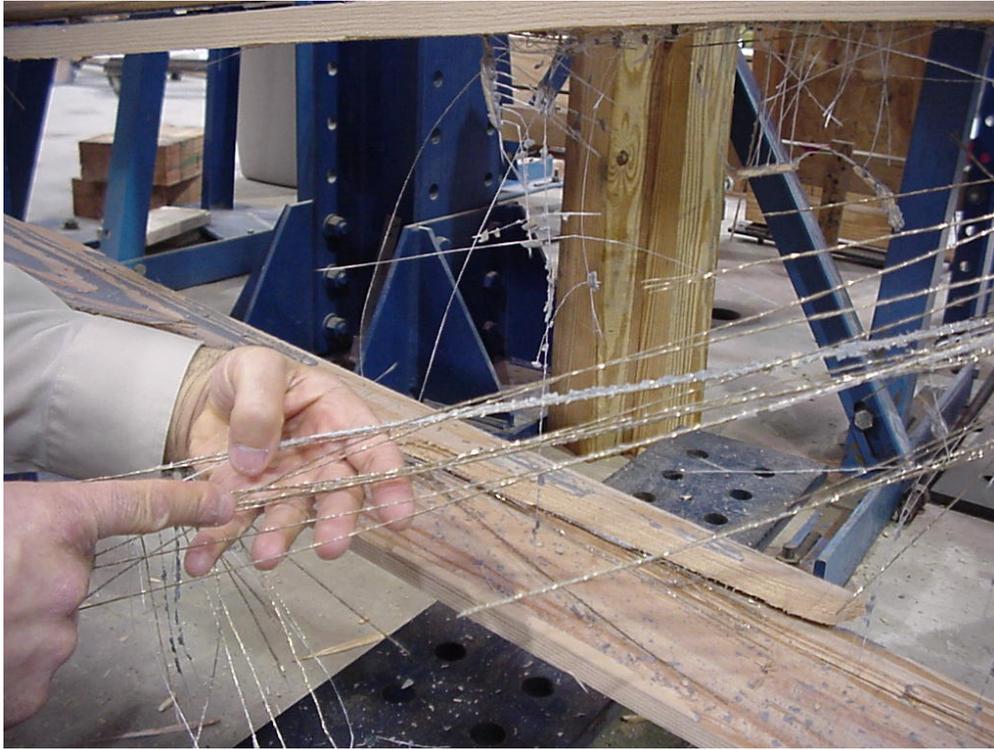
Figure 4: Typical condition of steel wires after beam failure for R-1, R-2, & R-3

Figure 3 provides the load-deflection plots for all 6 beams. Using the plots, note the brittle failures of the control beam, as well as beams R-1, R-2 and R-3. On the other hand, beam R-4 with the higher reinforcement level showed a ductile nearly elasto-plastic load-deflection response. The beams with the lower reinforcement level (R-1, R-2 and R-3) all failed in tension in the hardwire layer in the region of constant maximum moment between the two load heads. In these three beams, the hardwire fibers showed a 'broomstick' type of failure, and the failed fibers, which protruded from the sides of the beams at the location of failure had little to no resin on them, as may be seen in Figure 4.

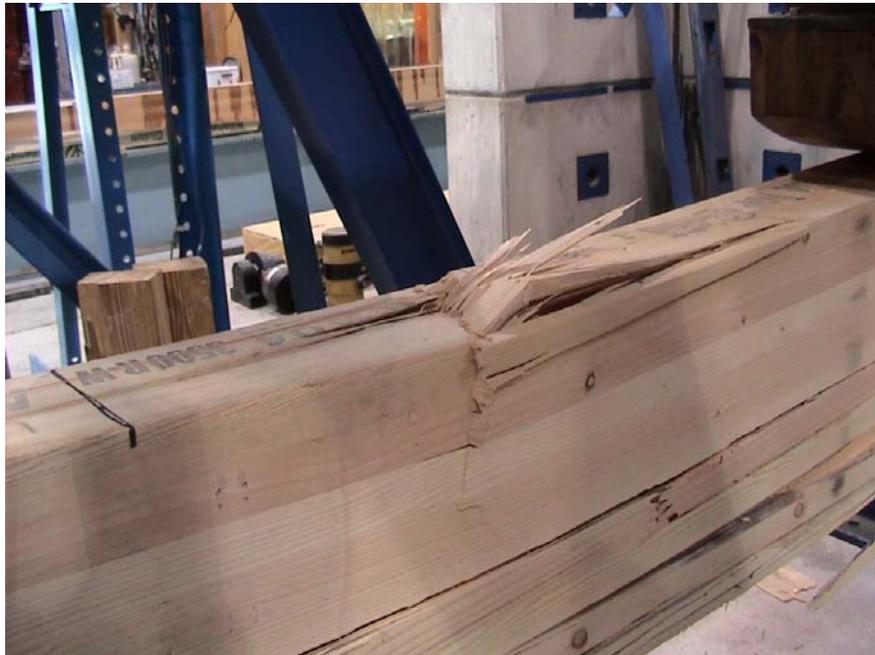
Figure 5: Compression failure of beam R-4

The beam with the higher reinforcement level (R-4) displayed a compression wrinkle in the top of the wood beam between the two load heads. This compression wrinkle was *visible* at a load of approximately 23-kips and propagated down through the top laminations (see Figure 5). The compression failure of beam R-4 explains the ductile, nearly elasto-plastic load-deflection curve in Figure 3.

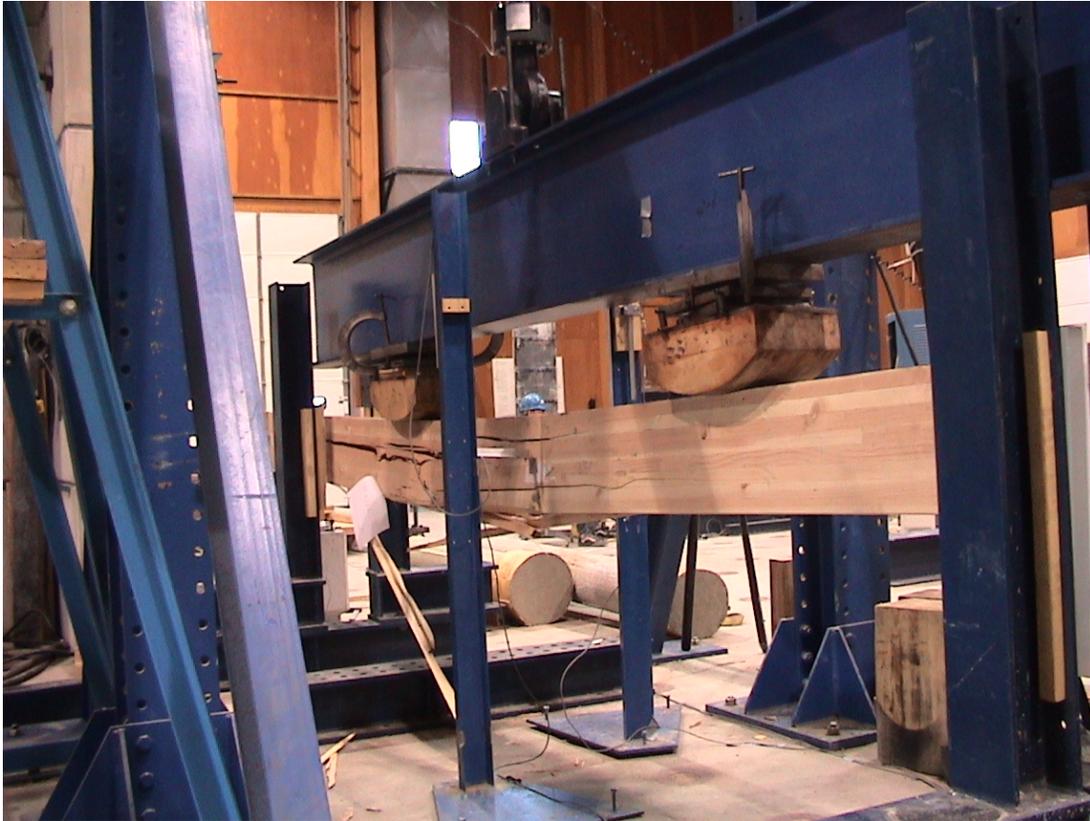
Figure 6: Control Beam Failure: 24F V4 DF/DF, no Reinforcement

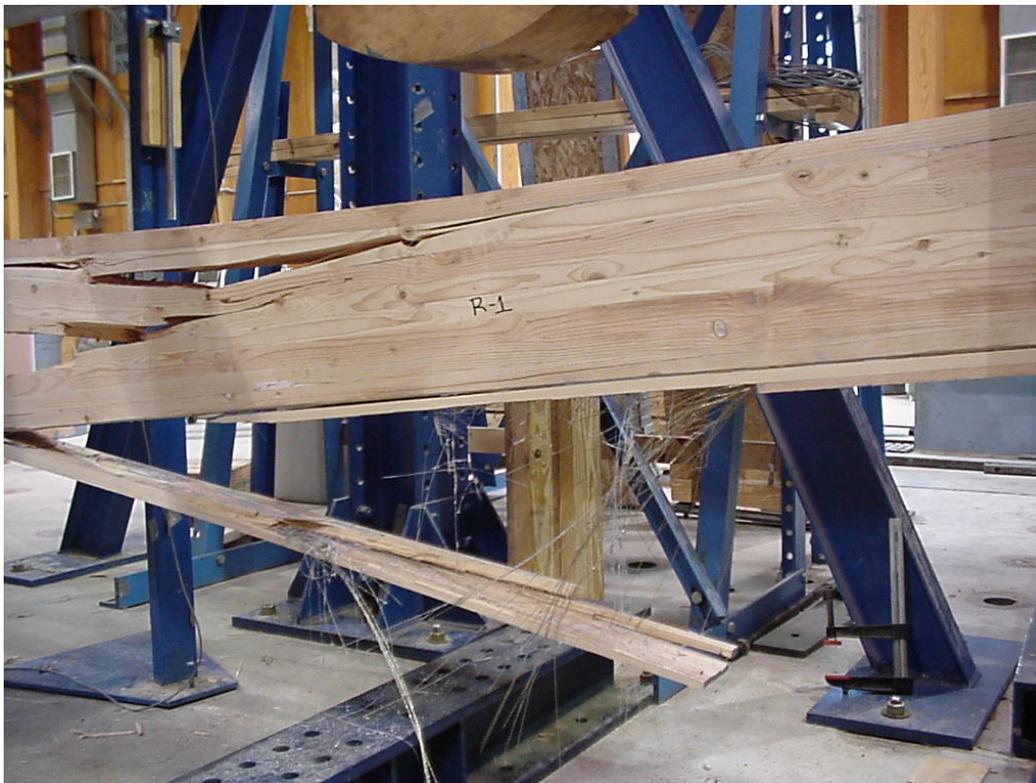
Figure 7: Hardwire Reinforced Beam R-1 Tension Failure

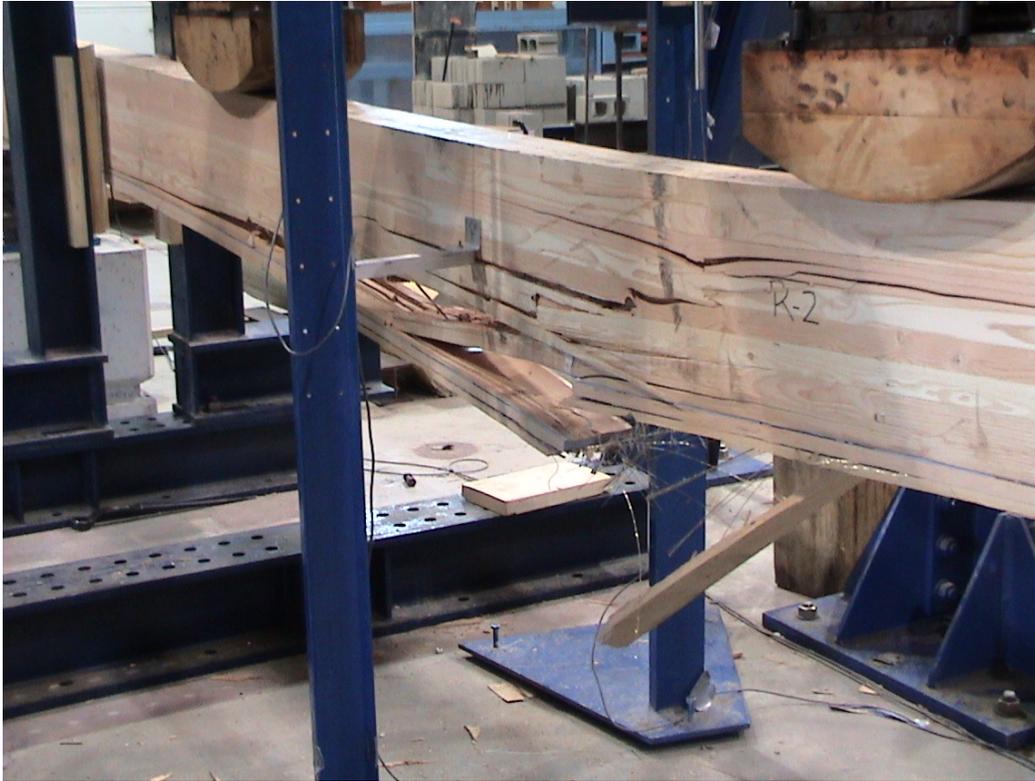
Figure 8: Hardwire Reinforced Beam R-2 Tension Failure

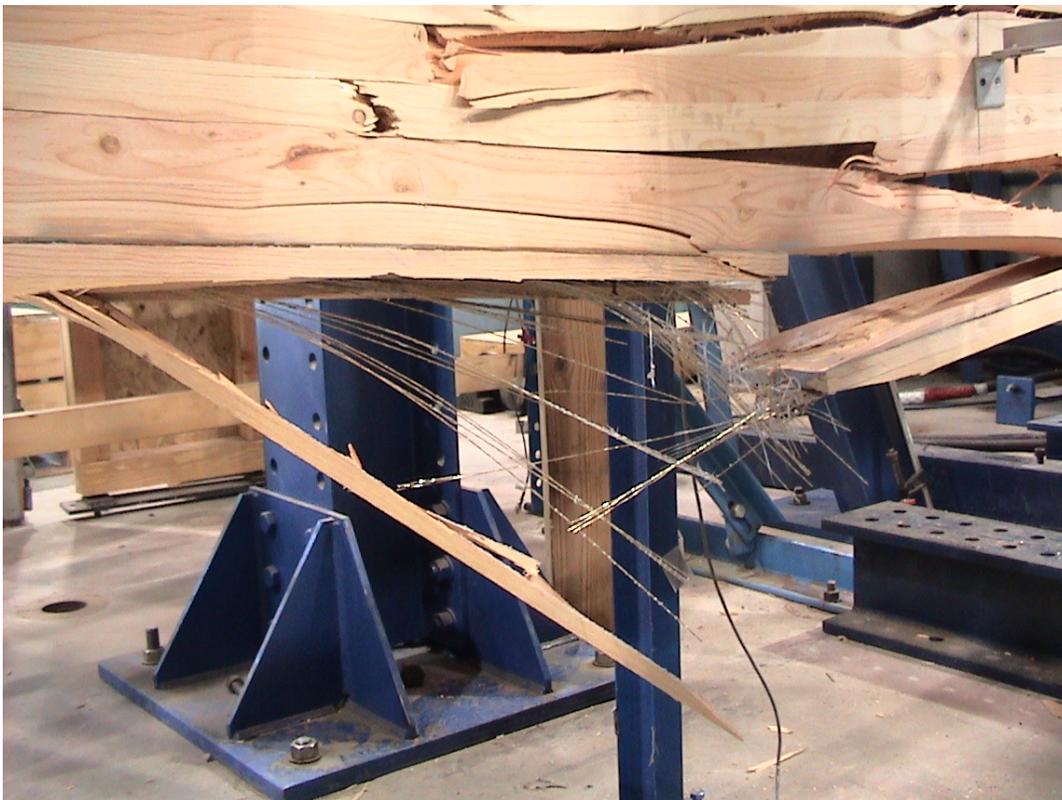
Figure 9: Hardwire Reinforced Beam R-2: Close-up of Tension Failure

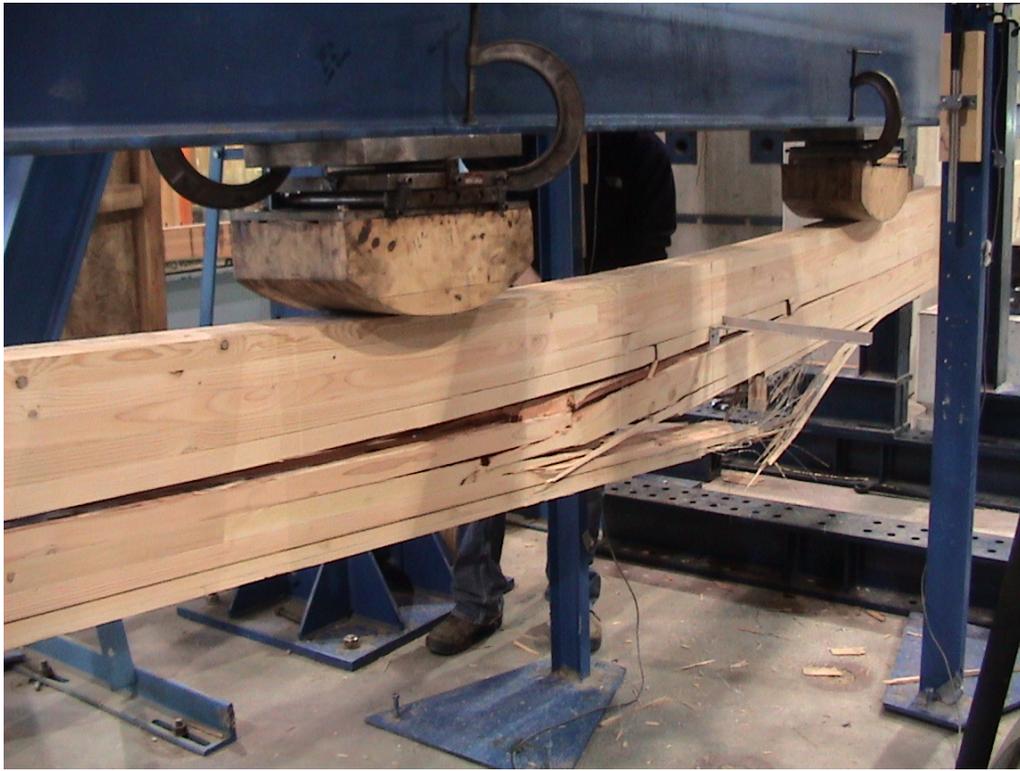
Figure 10: Hardwire Reinforced Beam R-3 Tension Failure

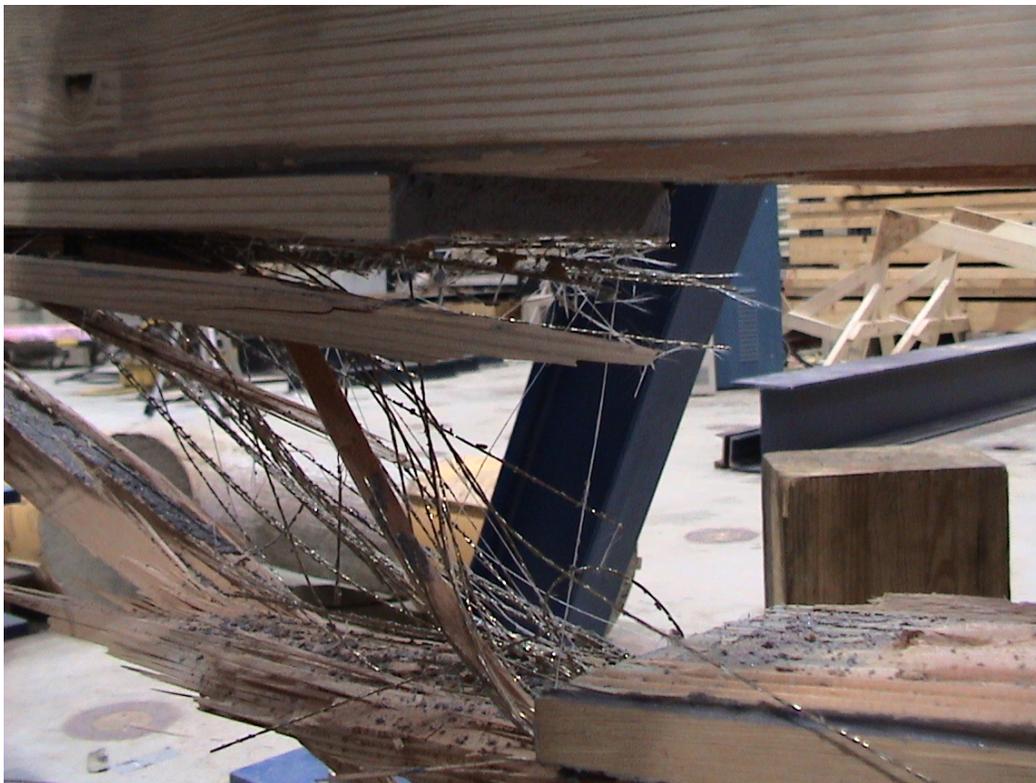
Figure 11: Hardwire Reinforced Beam R-3 – Close-up of Tension Failure

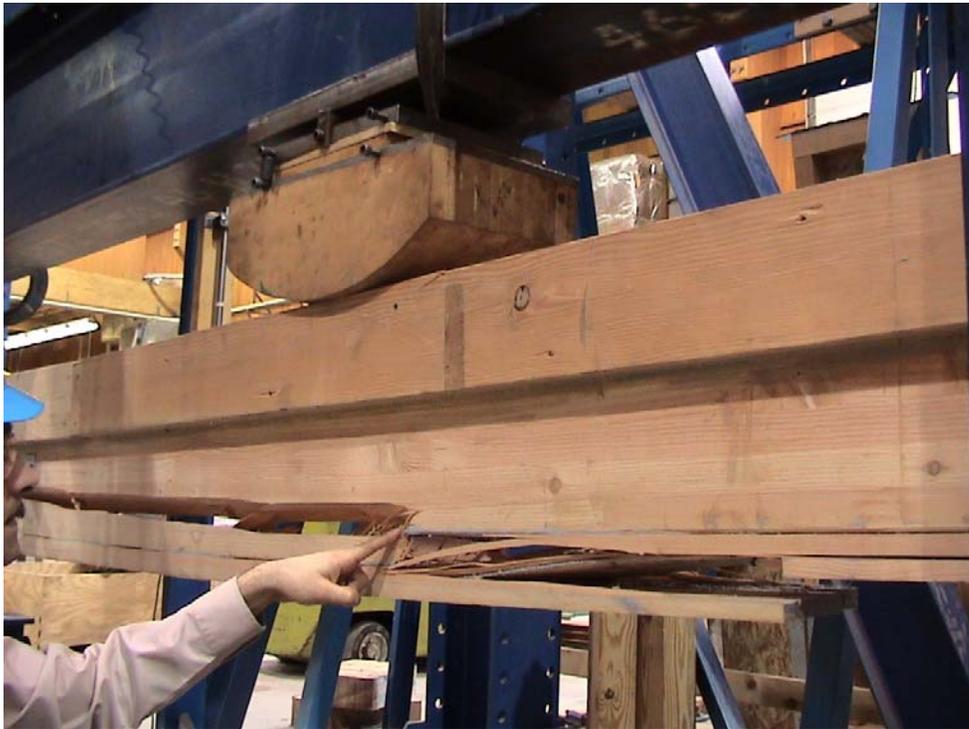
Figure 14: R-5 secondary tension failure in the bottom wood lamination of the original glulam. This was accompanied by a horizontal shear failure between the steel reinforcement and the wood directly above it from the load head to the right beam support (See Figure 15)

For the "T" beam, R-5, a shear failure began right under the bonded 2x6 under the left load head in Figure 13, then propagated towards the right load head, causing a tension failure in the bottom wood lamination of the original beam, followed by a shear failure directly above the reinforcement from the right load head in Figure 13 to the right end support.
