Test Report  
IS-04-09

### TENSILE TESTING OF HARDWIRE BAR.

## ASTM D 3039

### STANDARD TEST FOR TENSILE PROPERTIES OF POLYMER MATRIX COMPOSITE MATERIALS

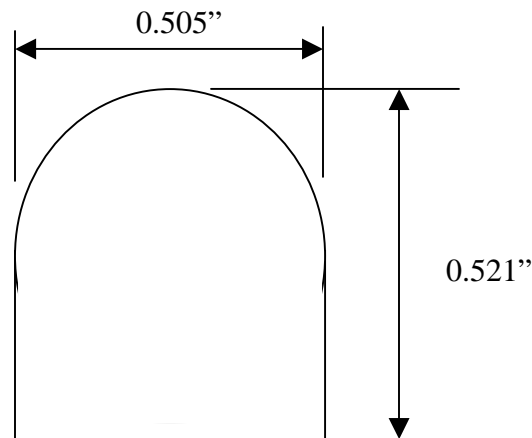
Figure 1 – Specimen Dimensions

An ASTM D 3039 tensile test was performed on a Hardwire™ composite bar provided by Structural Preservation Systems, Inc. The approximate dimensions of the bar cross section are provided in Figure 1. Using these dimensions the area of the bar was calculated to be  $0.236 \text{ in}^2$ . The bar provided was approximately 30" long.

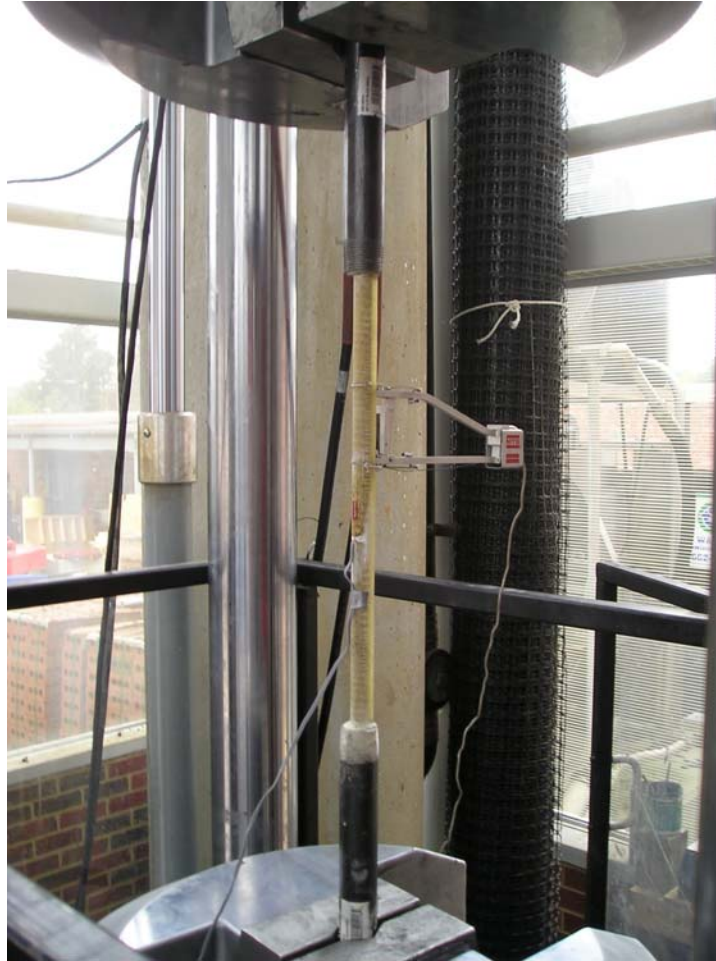
**Figure 1 – Test Setup**

Test specimen was prepared by placing each end of the bar in a 10 in. piece of steel tubing. The tubing was then filled with an expansive grout to provide a suitable mechanism for gripping as well as transferring load into the bars. A longitudinal strain gage was placed on each bar to measure the strain under load.

The specimens were gripped in a 220 kip MTS hydraulic wedge-grip machine. Load and stroke from the machine as well as the strain in the bar were recorded using an electronic data acquisition system at a rate of 1 point per second. Specimens were loaded using displacement control at a rate of 0.05 in/min. An extensometer was used to verify the initial readings of the strain gage but was removed prior to failure. Figure 1 shows the test setup.

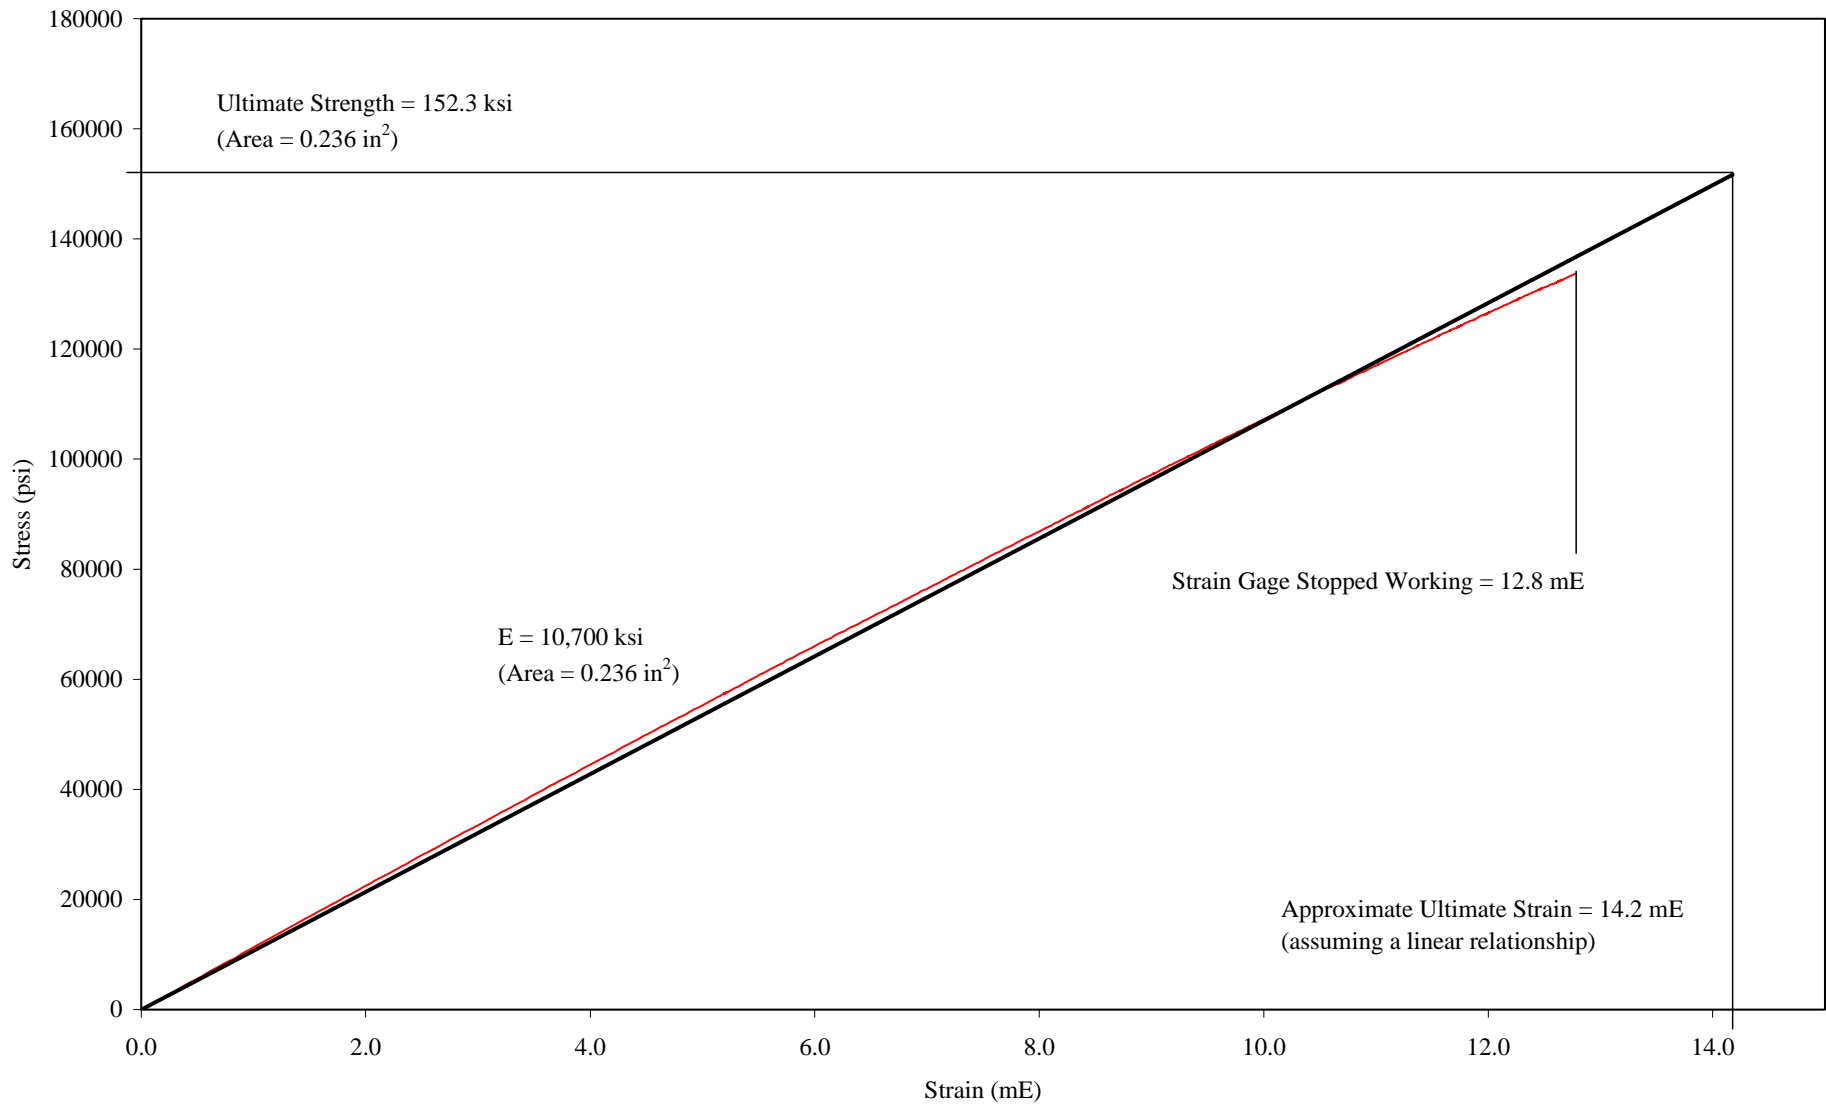
**Figure 2 – Stress-Strain Relationship**

The stress strain diagram for the specimens is shown in Figure 2. Figures 3 and 4 show the failed specimen. The failure was due to fracture of most of the Hardwire™ material at a single location. Approximately 25 wires in the center of the cross section did not fracture at the same location as the rest of the wires but did fracture elsewhere in the bar. The modulus was approximated to be 10,700 ksi. The ultimate strength was measured to be 152.3 ksi. The strain gage stopped reading at a value of 12.8 mE so an ultimate strain value was not determined. The ultimate strain was approximated to be 14.2 mE by assuming a linear stress-strain relationship.
