Test Report  
IS-04-11

**TENSILE TESTING OF HARDWIRE BAR.**

Structural Preservation Systems  
7455 New Ridge Road, Suite T  
Hanover, MD 21076  
Phone: 410-850-7000  
Web Site: [www.structural.net](http://www.structural.net)

### STANDARD TEST FOR TENSILE PROPERTIES OF POLYMER MATRIX COMPOSITE MATERIALS

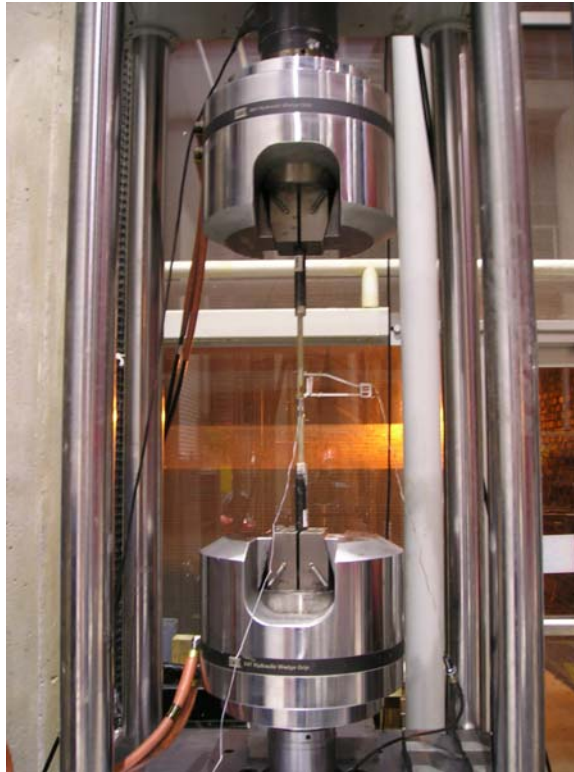
**Figure 1 – Test Setup**

The specimens were gripped in a 220 kip MTS hydraulic wedge-grip machine. Load and stroke from the machine as well as the strain in the bar were recorded using an electronic data acquisition system at a rate of 1 point per second. Specimens were loaded using displacement control at a rate of 0.05 in/min. An extensometer was used in addition to the strain gage to measure strains up to failure. Figure 1 shows the test setup.

Test specimen was prepared by placing each end of the bar in a 10 in. piece of steel tubing. The tubing was then filled with an expansive grout to provide a suitable mechanism for gripping as well as transferring load into the bars. A longitudinal strain gage was placed on each bar to measure the strain under load.
